### III - HISTORY OF PROJECT

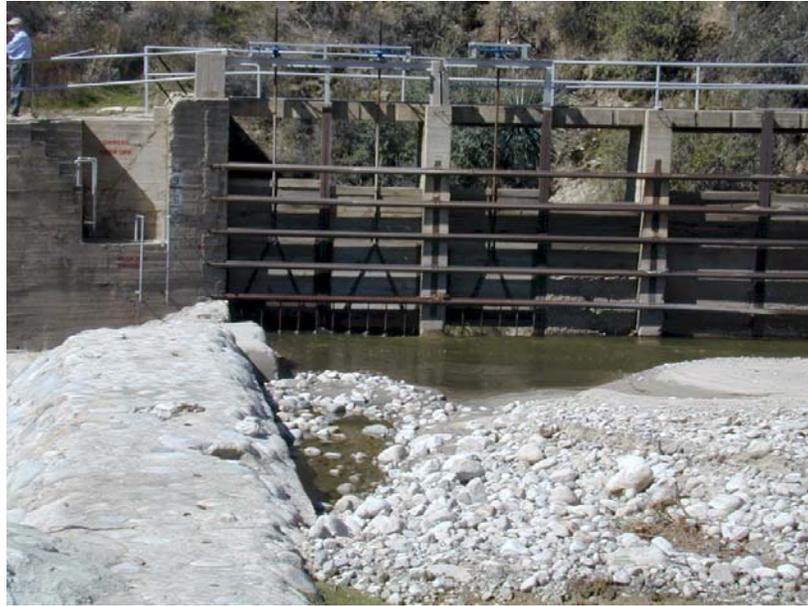
**Photo 3-1. Upstream View of SBVWCD Diversion Structure**

a. **Spreading Facilities Downstream of Seven Oaks Dam**. Currently, San Bernardino Valley Water Conservation District (SBVWCD) operates groundwater recharge facilities, downstream of Seven Oaks Dam. The existing recharge basins and additional basins currently under construction are located at a borrow pit formerly used for Seven Oaks Dam construction located west of Greenspot Road and north of the Santa Ana River. Some of the outflows from the Seven Oaks Dam outlet works are diverted at the SBVWCD diversion structure, located just downstream of the *USGS Santa Ana River near Mentone* stream gage (see Photos 3-1 and 3-2). From the diversion structure, the water flows through an underground box culvert, which is 10 feet wide by 9 feet high. The underground box culvert connects to a rectangular concrete channel, called a "sandbox," 400 feet downstream of the diversion structure. The purpose of the "sandbox" is to filter out excess sand carried in with streamflow. From the "sandbox", the water then continues to an unlined trapezoidal canal, flowing 2,300 feet to the west, crossing under Greenspot Road. The Parshall Flume, which is located at Greenspot Road, measures the flow as it continues west before finally entering the recharge basins at the borrow pit. At the present time, the Conservation District has 15 existing surface recharge basins, and additional recharge basins are now being constructed within the borrow pit. The SBVWCD groundwater recharge basins are shown on Plate 3-01.
