III - HISTORY OF PROJECT

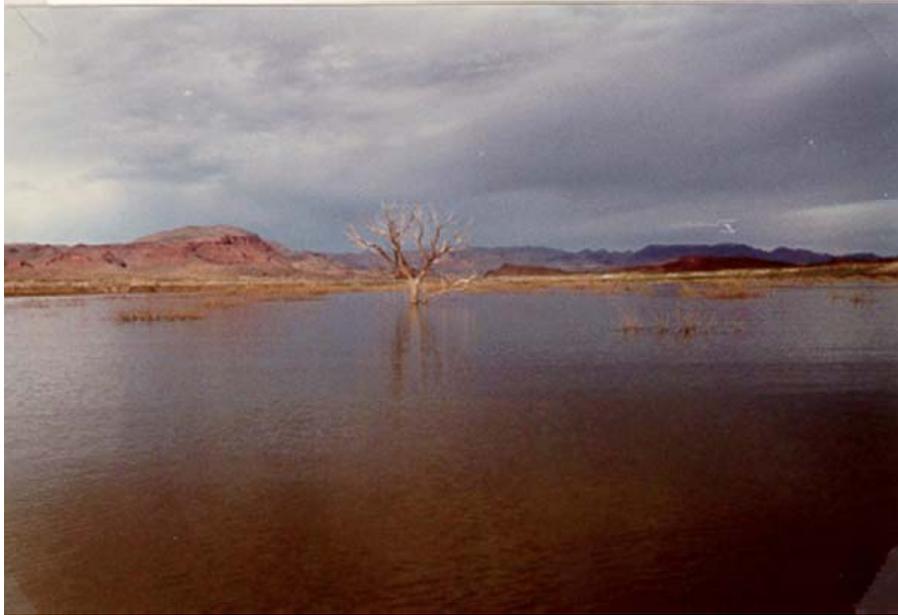
Photo 3-01. Partially inundated tree in upper reaches of Alamo Lake (lake elevation 1097.95 feet (334.7 m), 27 October 1987). Example of a tree where Southern Bald Eagles have nested within the lake.

d. **Southern Bald Eagles.** In early 1980's a pair of Southern Bald Eagles were discovered nesting in a partially inundated tree within the upper reaches of the Alamo Lake (Photo 3-01). Subsequently, another pair was discovered nesting in the canyon wall downstream from the dam. Occupation of the two nests prompted the USFWS to request that the lake elevation remain within the range of 1100-1135 feet (335.3 – 345.9 m) for the preservation of the eagles. The Bill Williams River Corridor Steering Committee addressed management needs for the bald eagle in development of the recommended plan, which was subsequently analyzed through the Alamo Lake, Arizona Feasibility Study and Environmental Impact Statement.

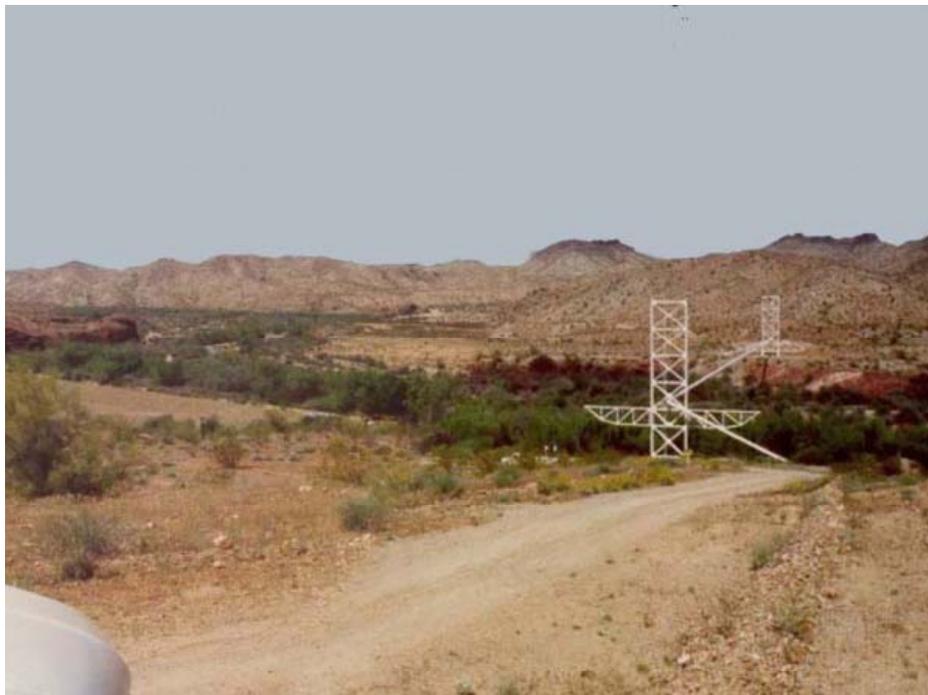
Photo 3-02. High-pressure gasline across Bill Williams River 13.5 miles below Alamo Dam.
